Dutch East India Company Shipbuilding

THE ARCHAEOLOGICAL STUDY OF
BATAVIA AND OTHER SEVENTEENTH-
CENTURY VOC SHIPS

Wendy van Duivenvoorde

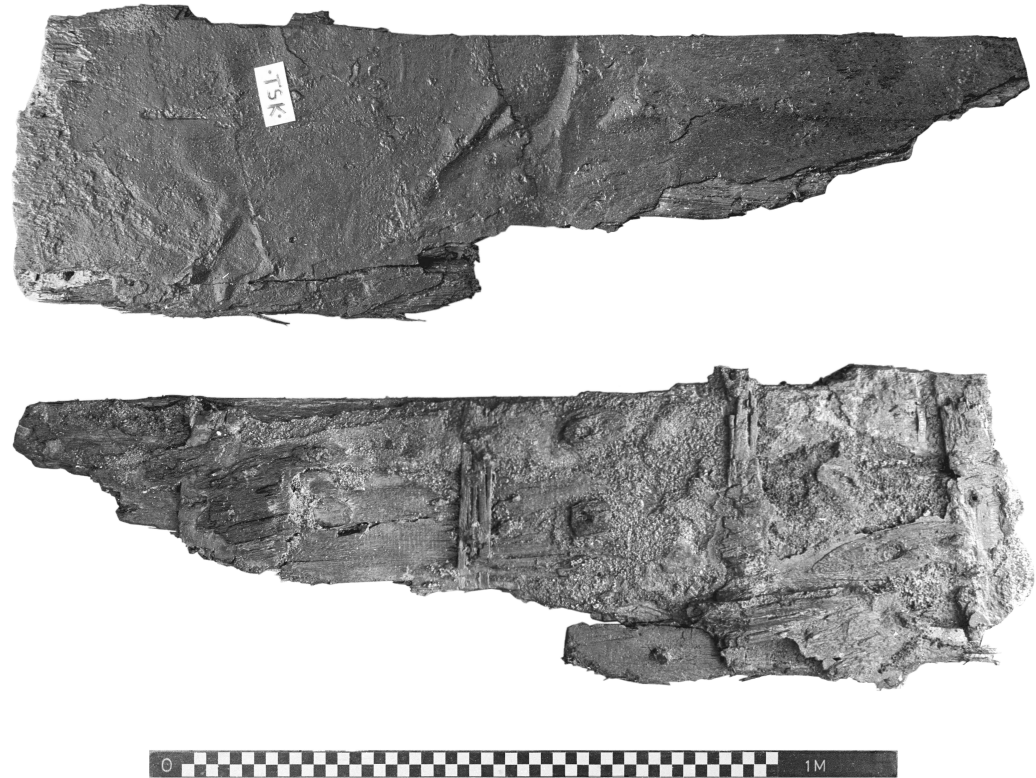
FIGURE 4-54. Internal (*top*) and outboard (*bottom*) surfaces of pine plank BAT 6273 from cargo floor. Note vestiges of laths on outboard surface. Photographs by Catherina Ingelman-Sundberg, Western Australian Museum (MA0399-11 and MA0399-12).

Originally, a pine cargo floor covered the ceiling planking up to the lower deck (fig. 4-52). Three fragmentary planks of this cargo floor have been well preserved on strakes 1-3. These planks measure from 1.71 to 1.90 m in length, and from 35.2 to 56 cm in width. Their maximum thickness varies from 2.6 to 3.6 cm. Two more fragmentary planks were found on the forward end of the shelf clamp (BAT 6089) and below ceiling planking strake 7 (BAT 6232). This pine floor was supported by small vertical laths nailed onto the ceiling planking that were found underneath the preserved floorboards (figs. 4-53 and 4-54). Most laths are about 6.3 cm wide, but one measures 7.7 cm. Their preserved lengths vary from 21.7 to 45.1 cm, and their thicknesses are only a few centimeters due to their poor state of preservation. Their room and space on plank BAT 6273 varies from 37.4 to 46.5 cm, and on strakes 5 and 6 it measures 57.7 cm.

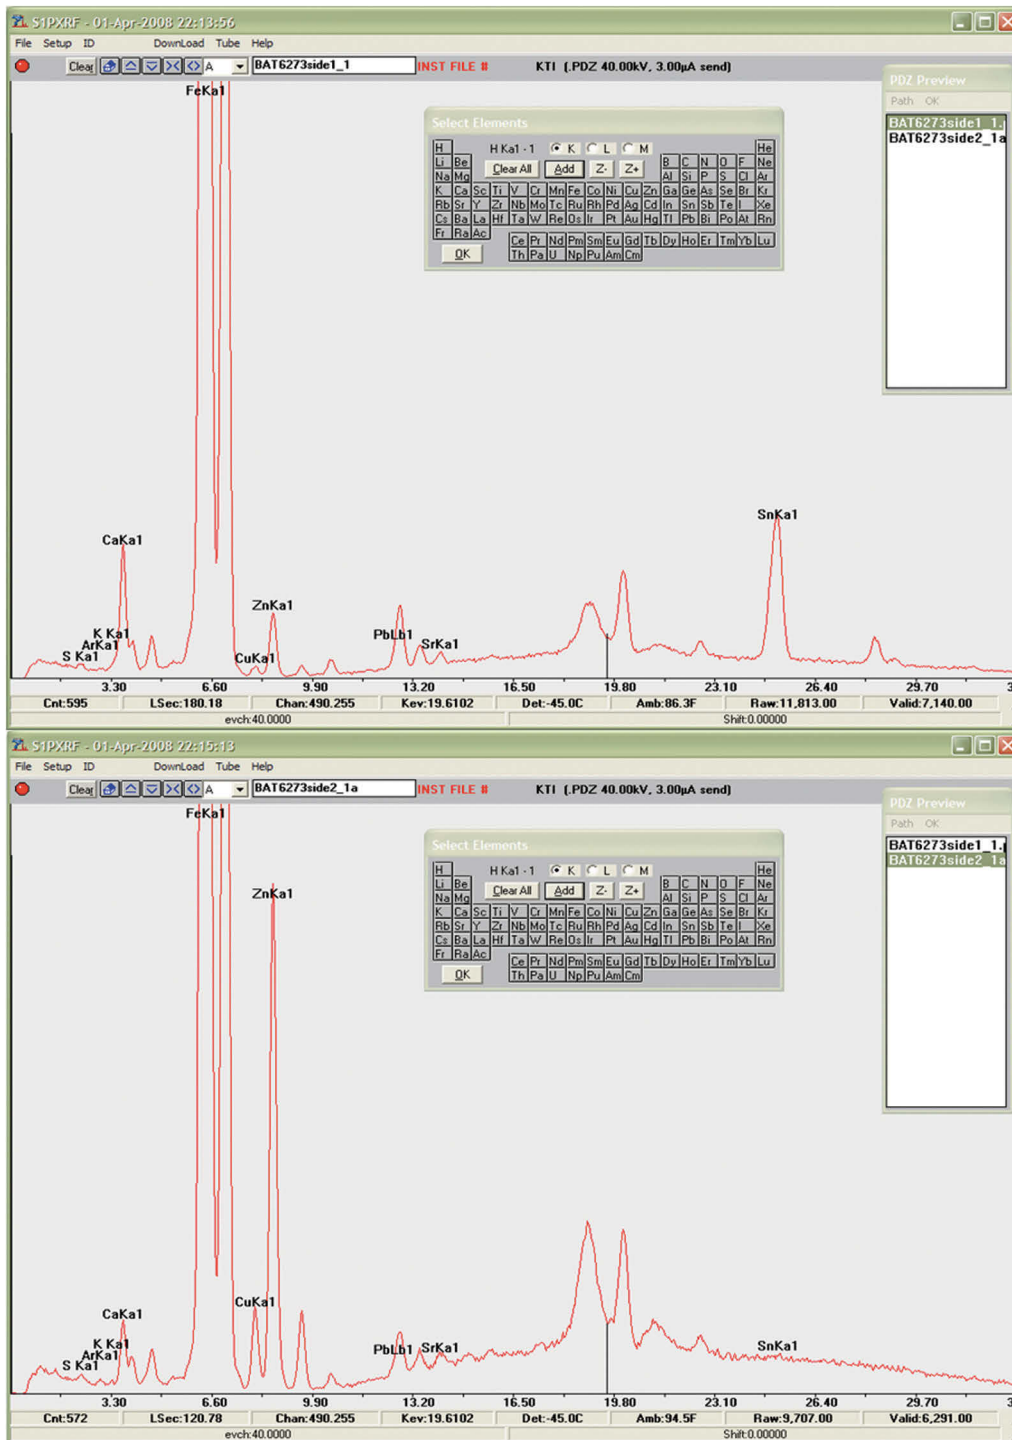
FIGURE 4-55. Screenshot of results of two XRF spot tests on pine floor plank BAT 6273. Illustrations by Bruce Kaiser.

of the Western Australian Museum using a Bruker AXS Handheld XRF apparatus. The chemical analysis was conducted on seven different spots on the planking's surface. The results mainly show high concentrations of iron and corrosion in the form of iron corrosion products and insignificant amounts of lead (fig. 4-55). If the cargo floor had been covered with lead sheathing, the amount of lead and lead corrosion products preserved on its surface would have been much higher due to the anaerobic conditions prevalent under the dense concretion. It is therefore more likely that the surface layer is a combination of anaerobic concretion and iron corrosion products formed from the corroding cannonballs.

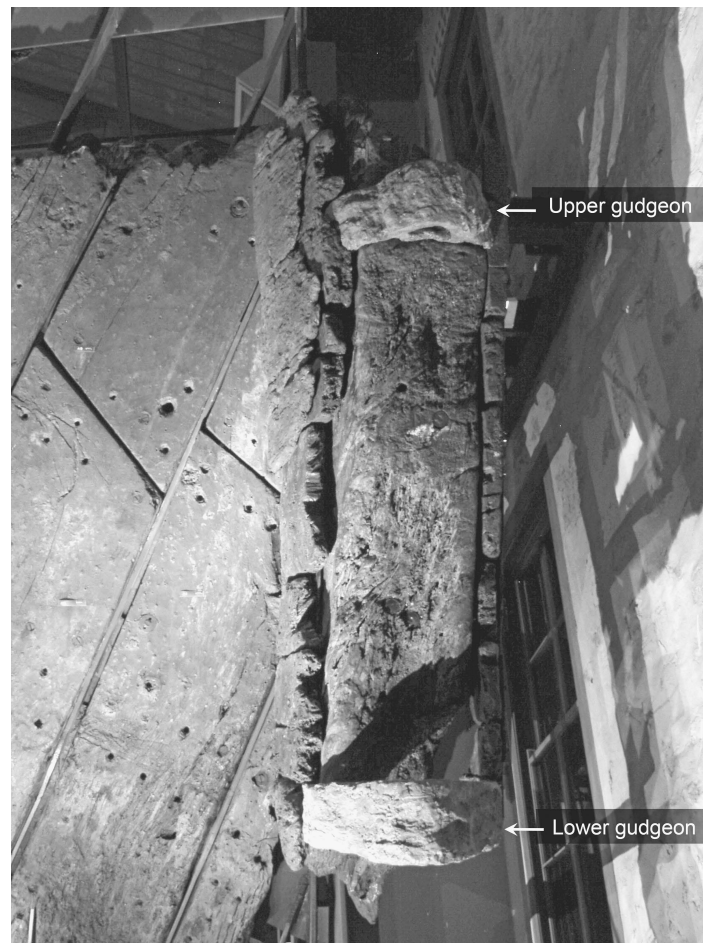
FIGURE 4-56.
After face of sternpost
with layer of oak cover
planking and pine
sheathing on starboard
and port sides.
Photograph by author.

As displayed in the museum, the after face of *Batavia*'s sternpost has an inclination of 107.5 degrees to the keel and an angle of approximately 114 degrees to the keel where it meets the transom planking. The sternpost was originally covered on each out-board side with several layers of material for additional reinforcement and protection (fig. 4-56). The innermost layer, nailed to the sternpost, was oak planking on top of which thin sheets of copper sheathing were added. A layer of pine sheathing was then fastened over the copper sheathing.⁶⁸ A thin layer of goat hair and a resinous substance was applied to the inner and outer surfaces of the pine sheathing.

The preserved section of sternpost measures 1.54 m in length over its aftermost face and 1.82 m over its foremost face (fig. 4-57). It measures 52.8 cm in molded dimension and tapers in sided dimension from 41.9 cm forward to 32.9 cm aft. An impression of the sternpost rabbet, preserved on its port side only, shows that the rabbet line was curved. As discussed previously, the transom planking had a curvature to it, which is clearly shown by the rabbet line. In addition, the sternpost was notched on its after face and on either side of the post to receive the rudder gudgeons (see fig. 4-56).

The second rudder gudgeon, BAT 80395, is the lower one from the preserved sternpost. This concretion has been cast for replication purposes and museum display (fig. 4-60; note that the upper gudgeon in fig. 4-56 is a replica of the lower gudgeon). The gudgeon was fastened to the sternpost with seven iron bolts or large spikes per side. The preserved

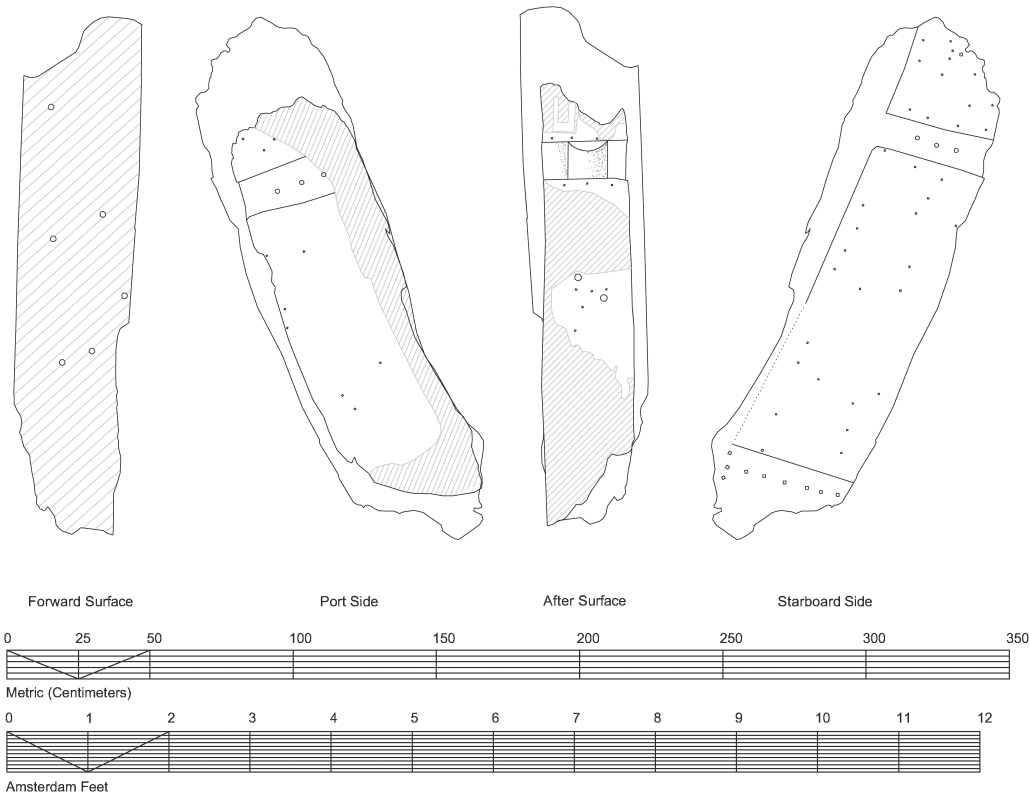
FIGURE 4-57.
Sternpost, BAT 6434.
Illustration by author.

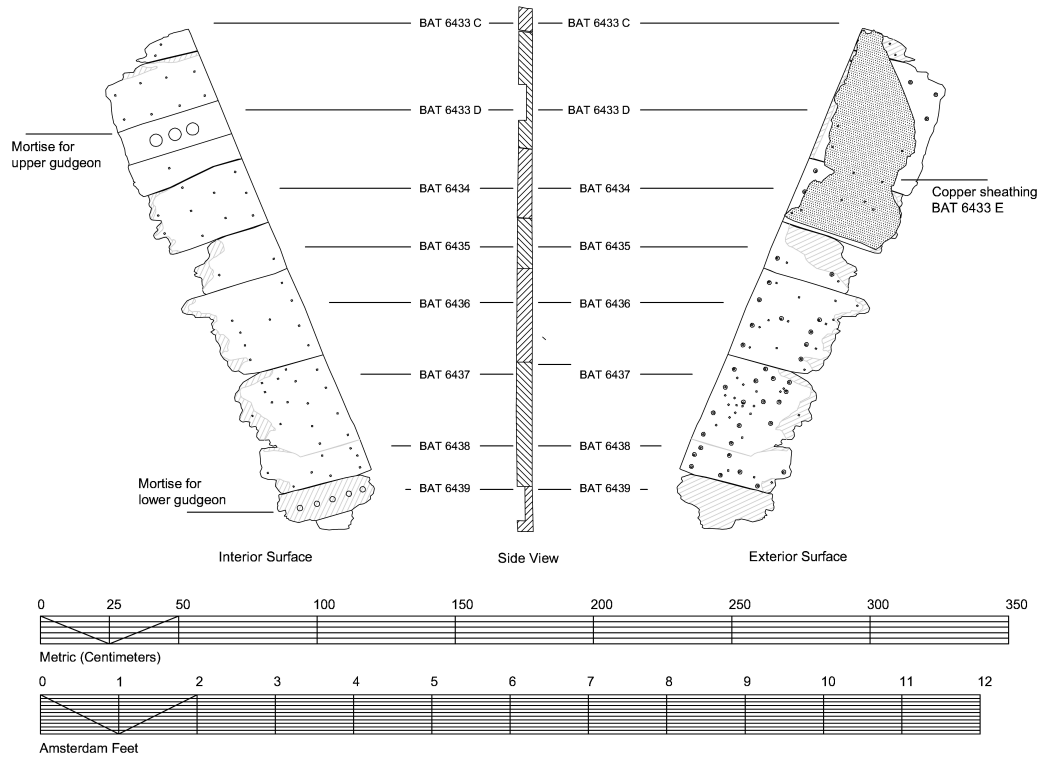
FIGURE 4-58.
Cover planking on
port side of sternpost,
BAT 6433 C–BAT 6439.
Illustration by author.

The concretions of two iron rudder gudgeons were found, but one, upper gudgeon BAT 80104, is still in wet storage and not available for study. Interestingly, the preserved transom planking indicates that the ends of this gudgeon flared on each side of the transom planking, where they were fastened between the two layers of transom planking on each side of the sternpost (see figs. 4-34 and 4-37). This practice provided strong lateral support for the gudgeons and its fasteners. The gudgeon arms were secured to the inner layer of transom planking by two iron spikes. The upper gudgeon was secured to the sternpost with large iron bolts, whereas the lower preserved gudgeon was fastened with smaller bolts or large iron spikes. The heads of the bolts from the upper gudgeon have left perfectly rounded circular impressions on the interior surface of the upper cover planking (measuring 4.5 cm in diameter; figs. 4-58 and 4-59).

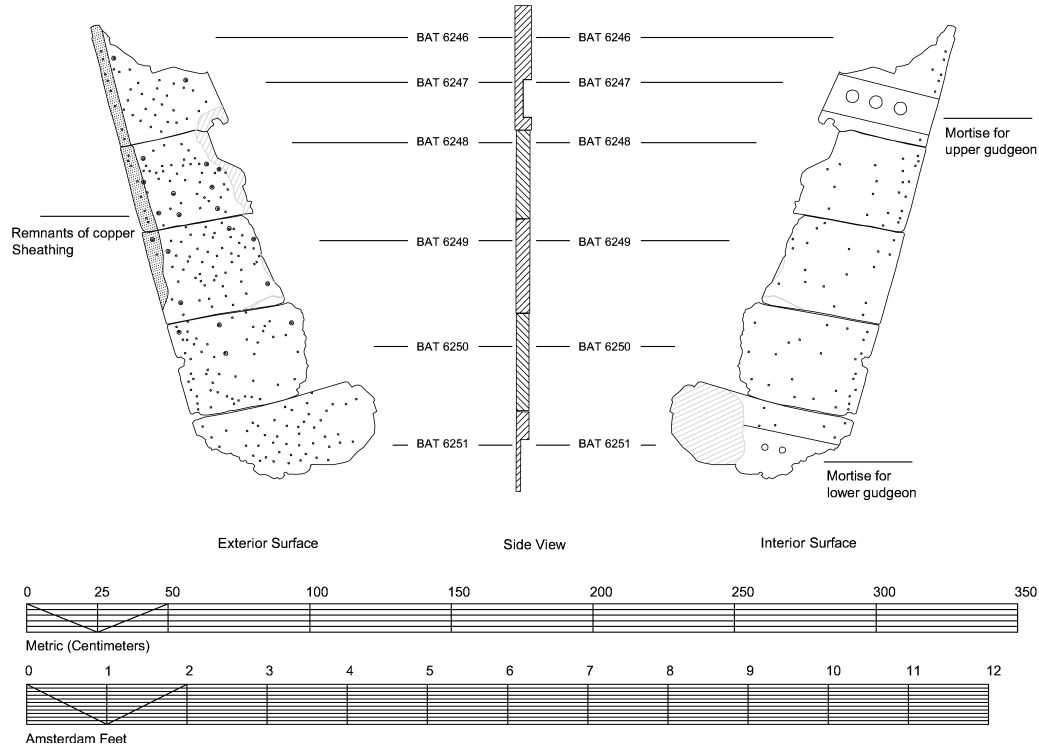
FIGURE 4-59.
Cover planking on
starboard side of
sternpost, BAT 6246–
BAT 6251. Illustration by
author.

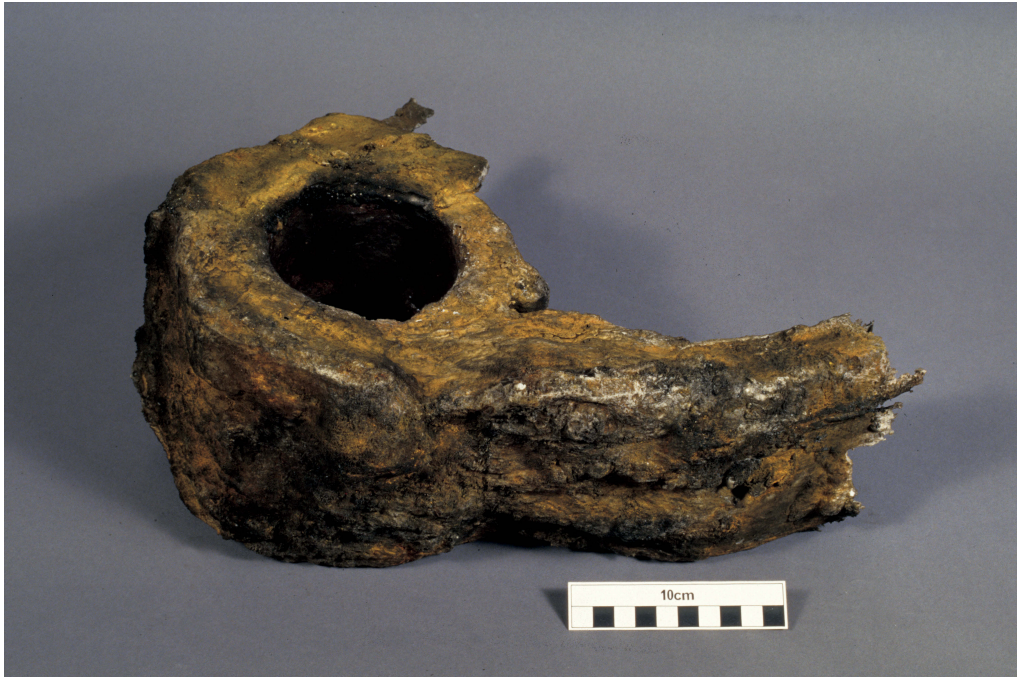
FIGURE 4-60. Casting of lower preserved gudgeon from iron concretion, BAT 80395 R. Photograph by Jon Carpenter, Western Australian Museum.

gudgeon measures 36 cm in length and tapers in width from 15.5 cm at its aftermost end to 11.4 cm where it runs in between the sternpost and the cover planking. It measures 3.8 cm in thickness, although it is slightly thicker, 5.5 cm, at its aftermost end where it seated the pintle. The hole for the pintle measures 8.5 cm in diameter.

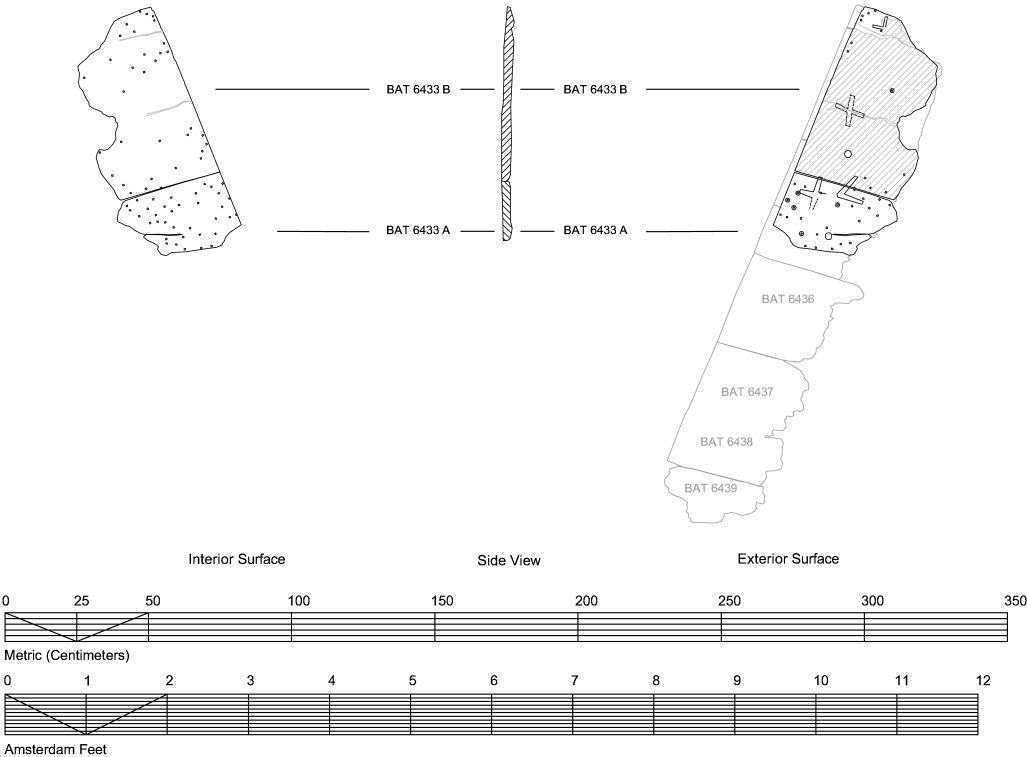
FIGURE 4-61.
Pine sheathing planks,
port side of sternpost,
BAT 6433 A and BAT
6433 B. Illustration by
author.

Seven fragmentary covering planks have been preserved from the sternpost's outboard port side and five on its starboard side (figs. 4-61 and 4-62). They vary in maximum length from 32.2 to 64.3 cm and in maximum width from 18.3 to 47.7 cm. The thicknesses of the planks measure from 4.5 to 5.8 cm, with an average of 5.3 cm.

Six planks of pine sheathing have been preserved that were nailed onto the cover planking on the starboard side and two on the port side (see figs. 4-61 and 4-62). They vary in maximum length from 19.3 to 56.6 cm and in maximum width from 15.9 to 61.9 cm. The thicknesses of the planks measure from 2.7 to 3.5 cm, with an average of 2.9 cm. Of the two layers of planking that protect the sides of the sternpost, the cover planking is slightly thicker than the sheathing.

The pine sheathing planking on the starboard side of the sternpost shows Roman numerals representing draft marks numbered from XVI to XX (see fig. 4-62).⁶⁹ On the port side, numbers XVIII to XXI have only partially survived (see fig. 4-61). The Roman numeral I is indicated by a single round dot, as are half values. The letters are a maximum

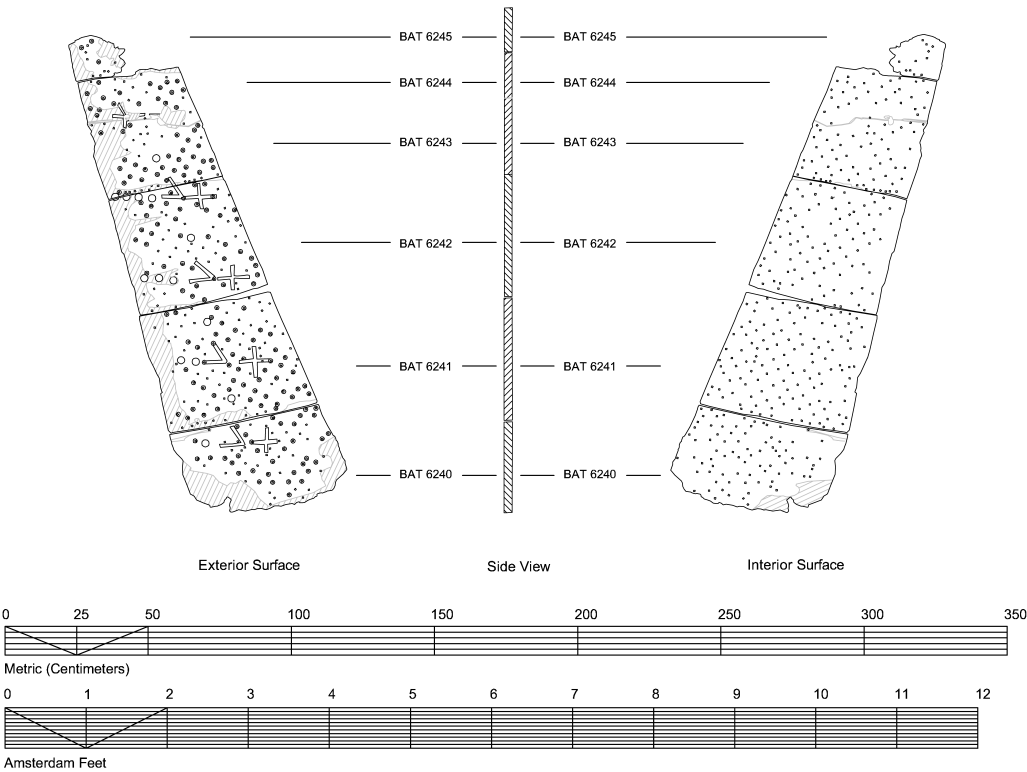
FIGURE 4-62.
Pine sheathing planks,
starboard side of
sternpost, BAT 6240–
BAT 6245. Illustration by
author.

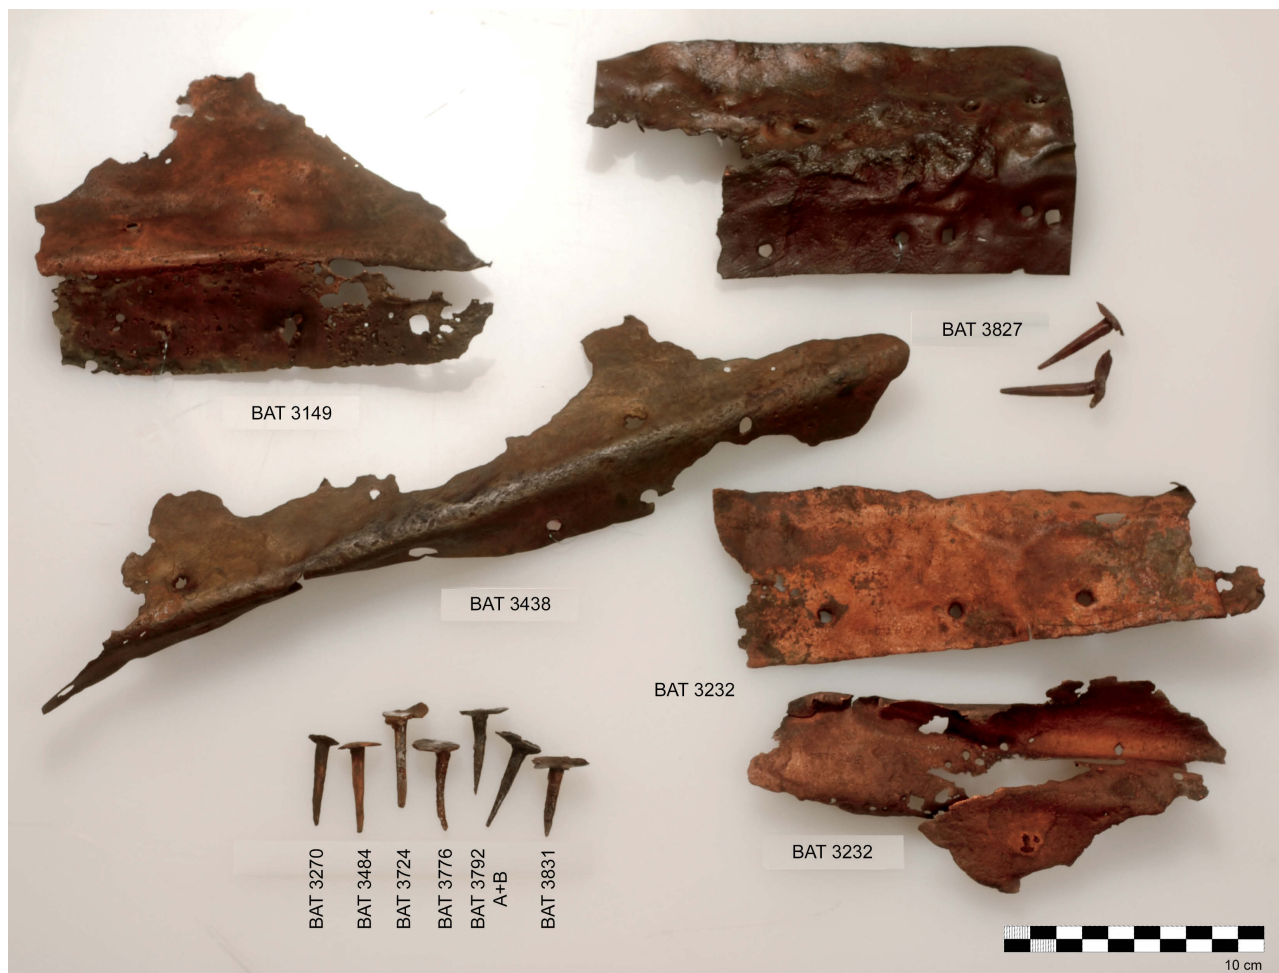
FIGURE 4-63. Fragments of copper sheathing and tacks from sternpost. Photograph by Patrick Baker, Western Australian Museum.

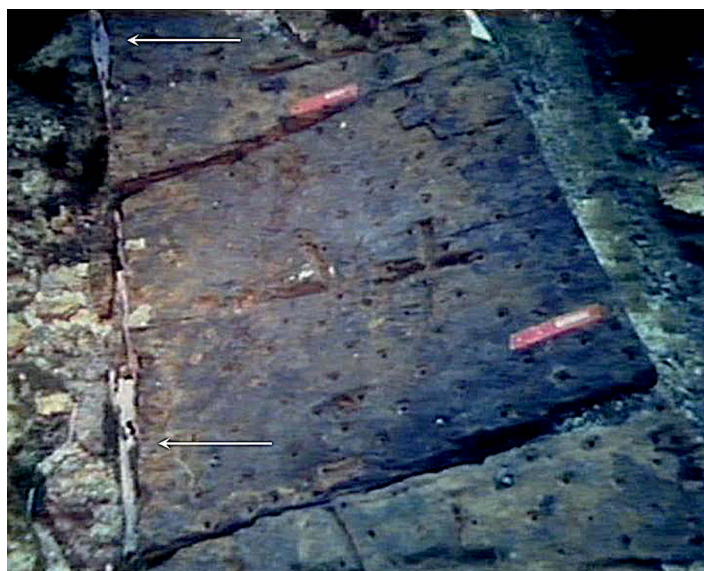
FIGURE 4-64.
Fragments of copper sheathing protruding along the edge (arrows) from beneath the starboard pine sheathing of the sternpost. Photograph by ABC Peach's Australia, *The Unlucky Voyage*, 1990, Western Australian Museum.

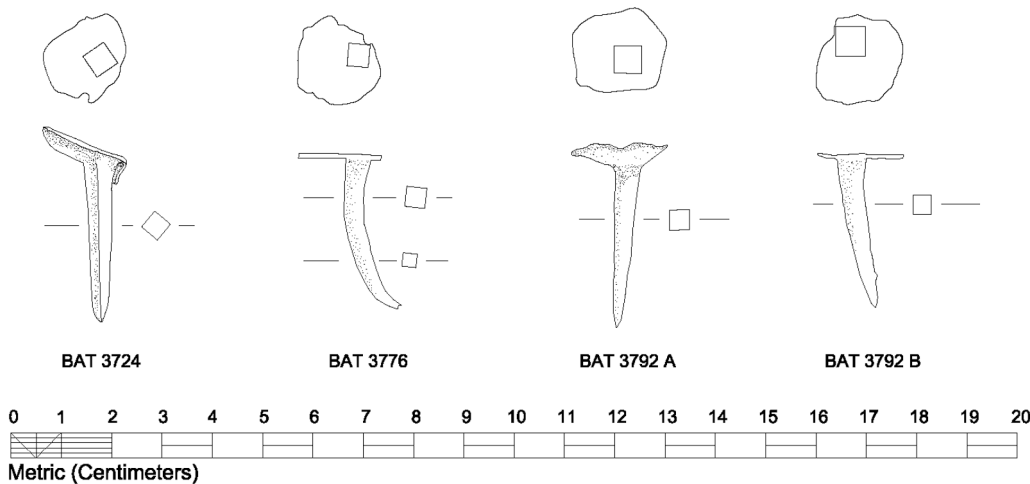
FIGURE 4-65.
Copper tacks for
fastening copper
sheets to the sternpost.
Illustration by author.

The preserved copper tacks have irregular flat heads, indicating that the soft metal was flattened and deformed when driven into the wood (fig. 4-65). Their shanks are square in section (6 mm) from below their heads to the tips and taper in thickness to about 2 mm. Their tips are pointed. The copper tacks have an average length of 3.1 cm. Their heads vary in diameter from 1.1 to 2.3 cm, and their head thickness generally tapers from 3 mm in the centers to 1 mm at the edges.

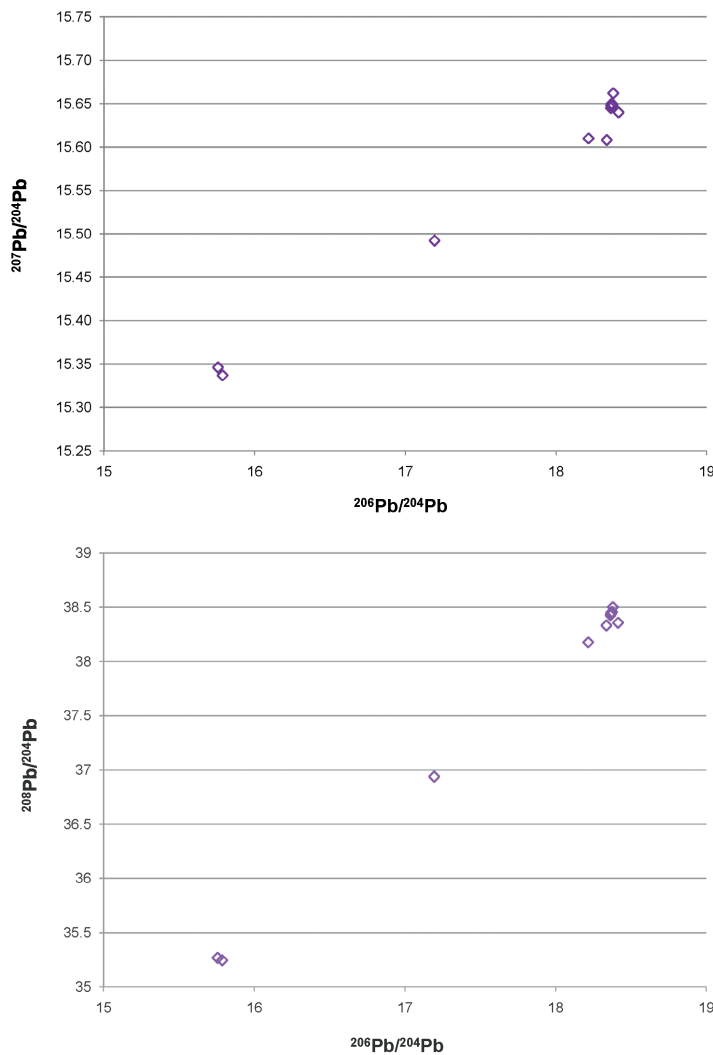
FIGURE 4-66.
Charts plotting lead isotope
values of copper tacks and
sheathing. Illustration by Kjell
Billström.

Bergslagen and Japanese leads) in both the $^{206}\text{Pb}/^{204}\text{Pb}$ versus $^{207}\text{Pb}/^{204}\text{Pb}$ and $^{206}\text{Pb}/^{204}\text{Pb}$ versus $^{208}\text{Pb}/^{204}\text{Pb}$ diagrams, it is suggested that this lead represents a mixture of lead from two ore districts.

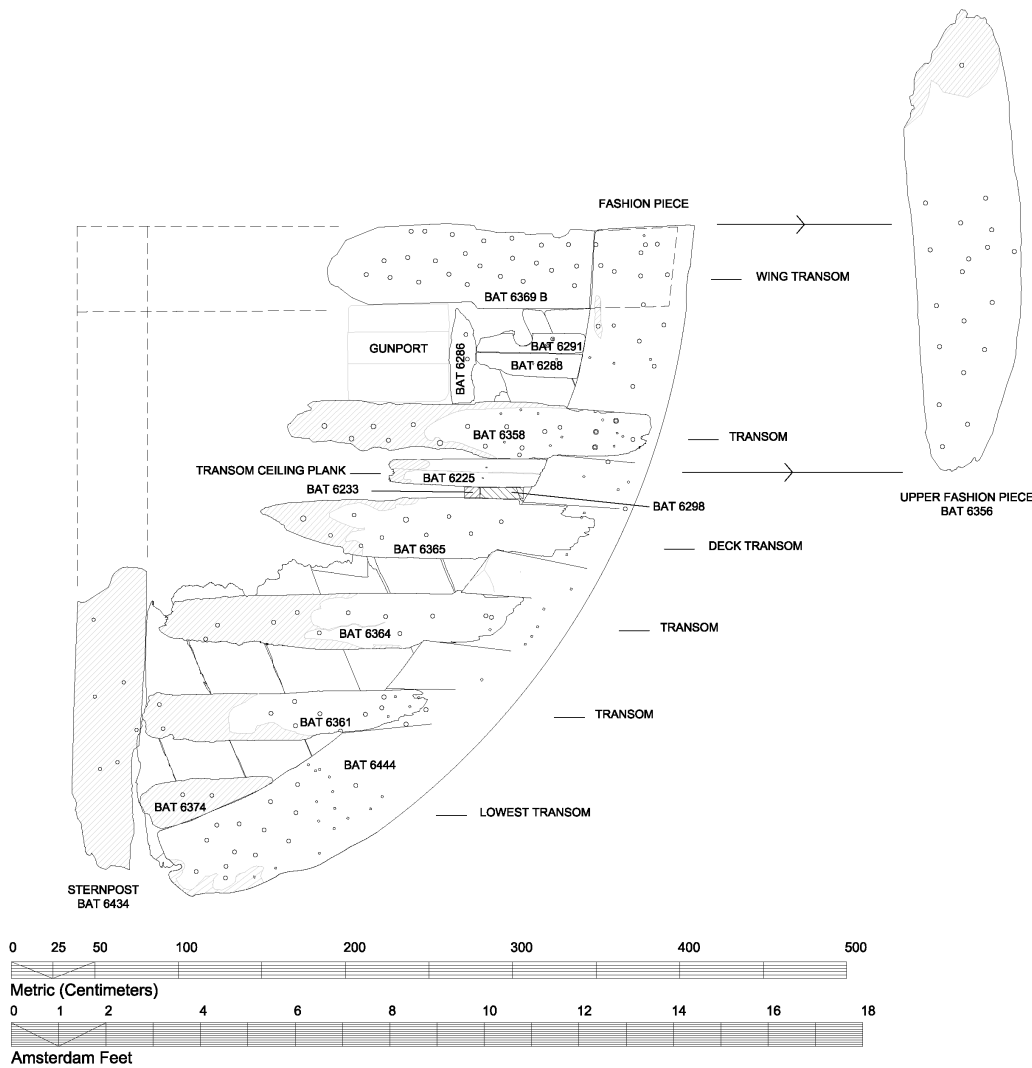
FIGURE 4-67.
Transom timbers,
looking aft. Illustration
by author.

and four large dovetails, spaced at set intervals, along its length on its forward face. These dovetails receive the ends, each vertically flat scarfed, of four transom beams, BAT 6358, BAT 6361, BAT 6364, and BAT 6365 (see fig. 4-67). The flat scarf at the fashion piece's top end is nibbed for 3.6 cm and then measures 49.4 cm in length and spans the entire molded dimension of the fashion piece.

The upper fashion piece was bolted on its top forward end where it sits flush over the highest transom beam, BAT 6358, and was only partially preserved over a length of about 2.8 m (see figs. 4-67 and 4-69). It measures roughly 68 cm sided and 24 cm molded. At least 18 iron bolts fastened it to the fashion piece.

The upper ends of *Batavia*'s diagonal transom planking terminated at a wing transom (figs. 4-67 and 4-70). The partially preserved port side of this piece was found on the seabed with a concreted hinge fitting for a gun port. Wing transom BAT 6369 B is preserved only on the transom's exterior face where it scarfs over the aftermost face of the fashion piece. Its preserved dimensions are approximately 2.1 m in length, 50 cm

On top of the wing transom, on the exterior surface of the upper fashion piece, a standing knee, BAT 6357, reinforced the transom and hull planking on the side of the ship. Only partially preserved, it measures 1.17 m in length, 76.8 cm in width, and 27.8 cm in thickness (see fig. 4-67). It was fastened to the hull planking and wing transom by at least five iron bolts but not to the upper fashion piece.

Batavia's transom was reinforced by five transom beams below the wing transom, all of which were placed parallel to one another at intervals of roughly 25 cm (nearly 1 Amsterdam ft). Only the three lowest transom beams, BAT 6374, BAT 6261, and BAT 6262, have been preserved from the transom's exterior edge to the sternpost. Bolt holes at the forward end of the sternpost suggest that these transom beams were notched on their after faces to fit over the sternpost (see fig. 4-67).

As described previously, the four transom beams between the lower transom and wing transom were dovetailed into the fashion piece (figs. 4-67 and 4-72). They are preserved over lengths varying from 1.71 to 2.19 m, measure between 32 and 41 cm sided, and 36 and 41 cm molded. The second transom beam below the wing transom, BAT 6365, comprises the deck transom beam (see fig. 4-67).

On top of the after arm of the third transom knee, BAT 6295, parallel to the transom, two oak planking remains run in a longitudinal direction. They are not deck planking but planks of a platform that rested on this transom knee and probably supported the two transom cannon (see figs. 4-67 and 4-77). The oak planking fragments vary in thickness between 7 and 7.5 cm.

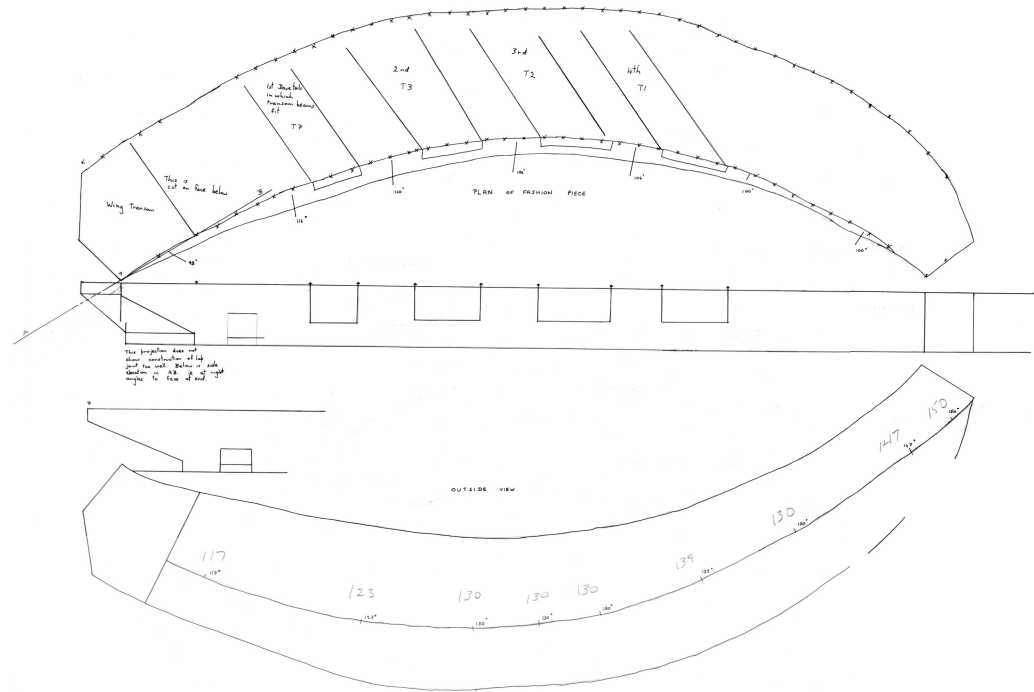
FIGURE 4-68.
Sketch of fashion piece,
BAT 6444. Illustration
by author.

On each side of the stern, the corner of the transom and side of the hull were reinforced by a fashion piece and transom knees, five of which were preserved. The fashion piece BAT 6444 is the single largest timber raised intact from the seabed, measuring about 4.6 m in length, 60 cm sided, and 32 cm molded (figs. 4-67 and 4-68). The after surface of the fashion piece has a maximum preserved sided dimension of 46.9 cm, as it was chamfered to accommodate the angle between *Batavia*'s transom and port side. The fashion piece terminates at the top of the wing transom.

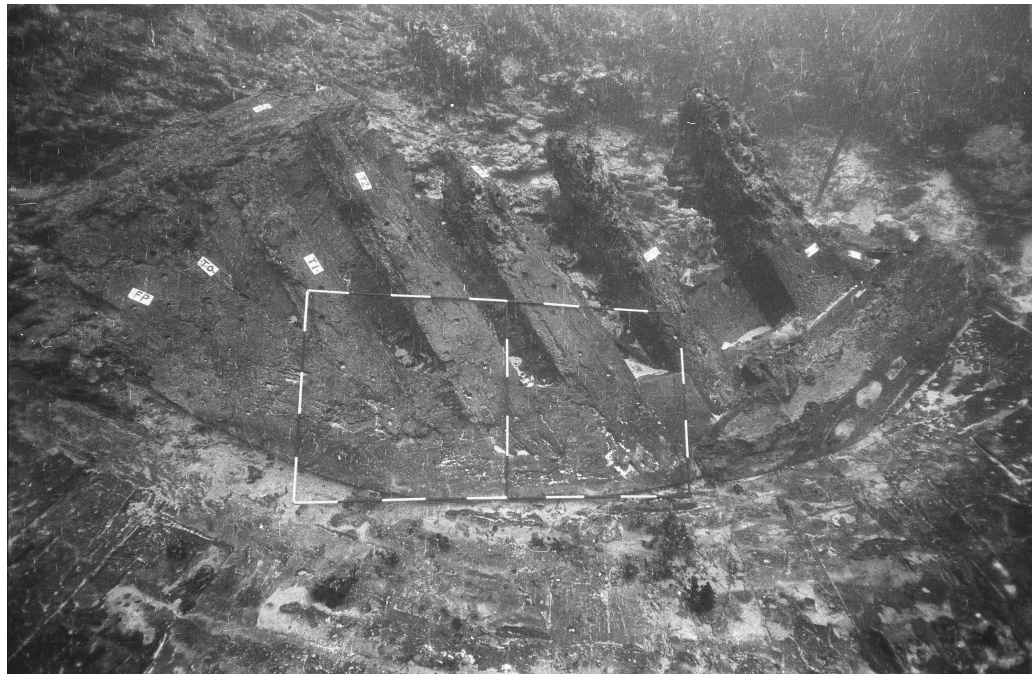
FIGURE 4-69.
Transom timber
assembly in situ.
Photograph by Patrick
Baker, Western
Australian Museum
(MA0410-35).

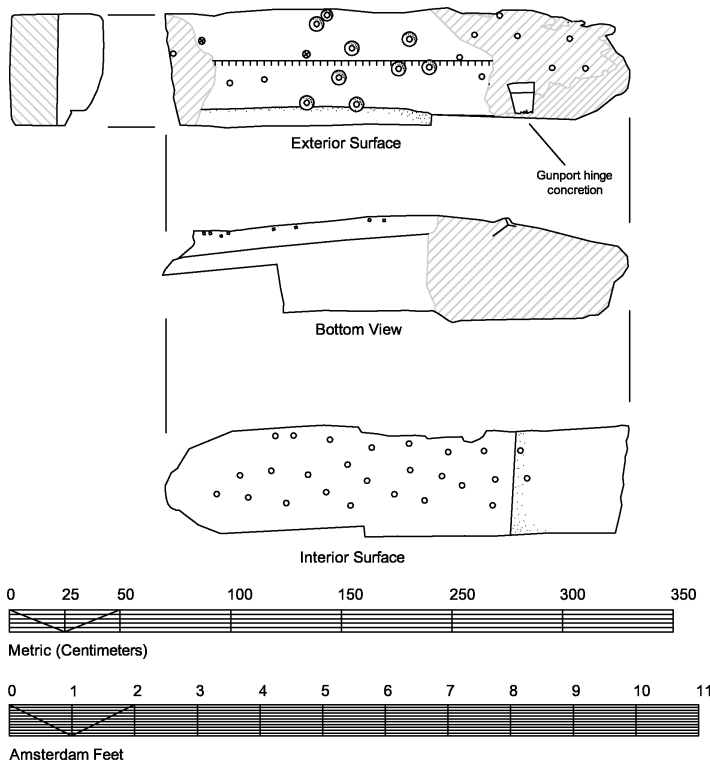
FIGURE 4-70.

Schematic drawing of
wing transom, BAT 6369 B.
Illustration by author.

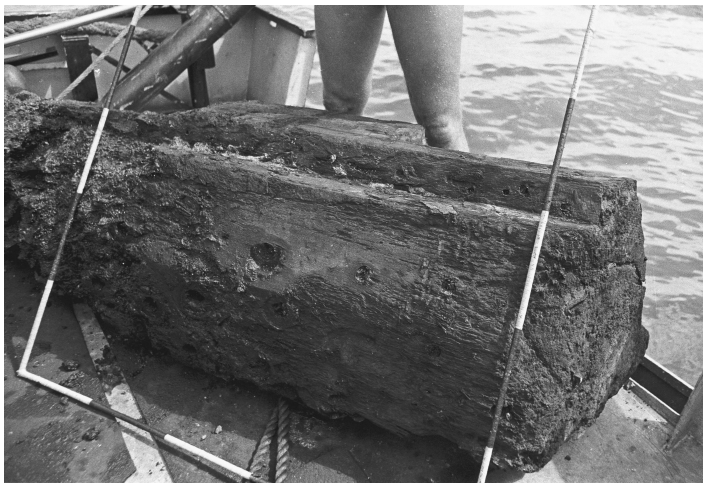
FIGURE 4-71.

Chamfered after surface
of wing transom with
rabbet to receive transom
planking (timber is lying
upside down), BAT 6369.
Photograph by Patrick Baker,
Western Australian Museum
(MAO414-15).

sided, and 43 cm molded. The scarf end is nibbed 4 cm and measures 5.1 cm in length. At the aftermost lower end a rabbet was cut to receive one layer of transom planking (10 cm in width; fig. 4-71).

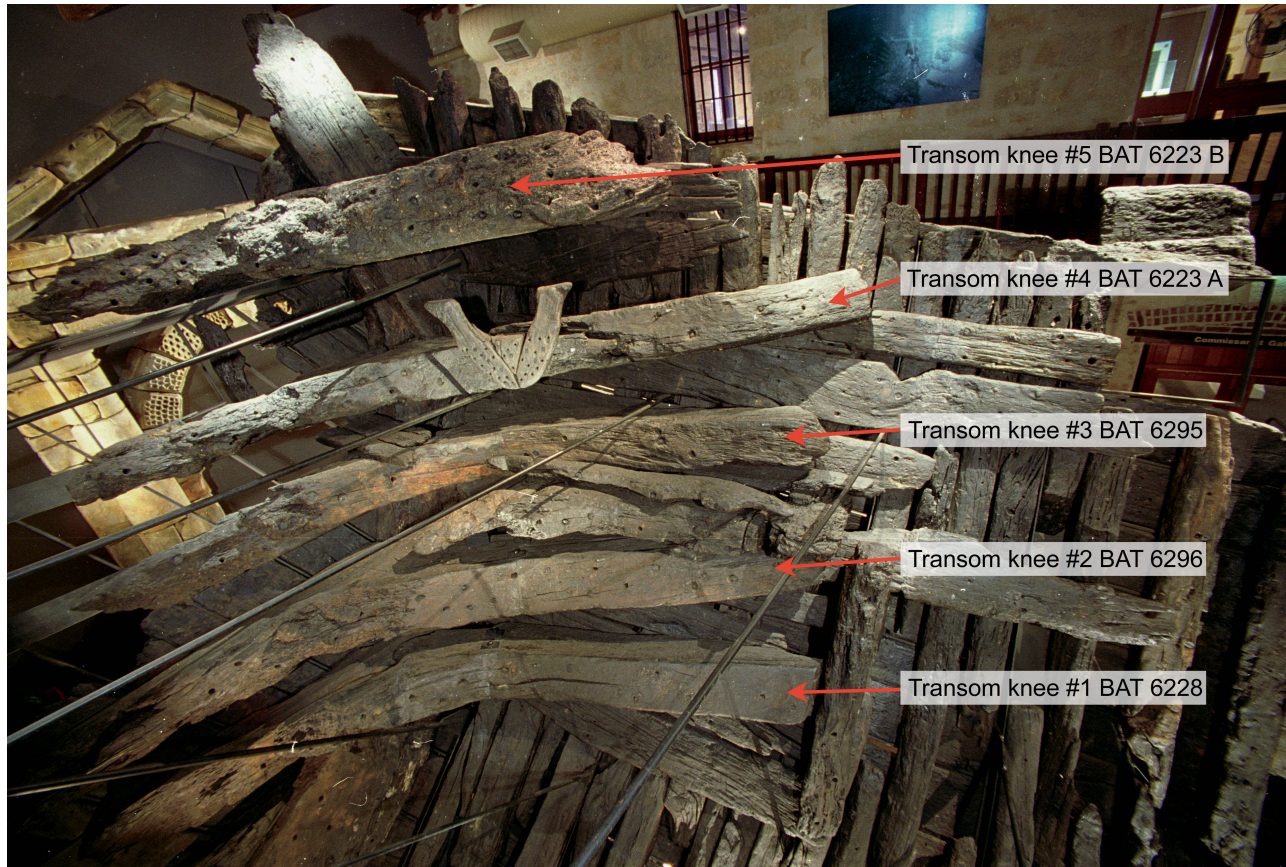
FIGURE 4-72. Transom beams. Photographs by Patrick Baker, Western Australian Museum (MAo415-31, MAo415-34, MAo415-35, MAo415-36, MAo416-05, MAo416-06, MAo416-07, MAo416-12, and MAo416-13).

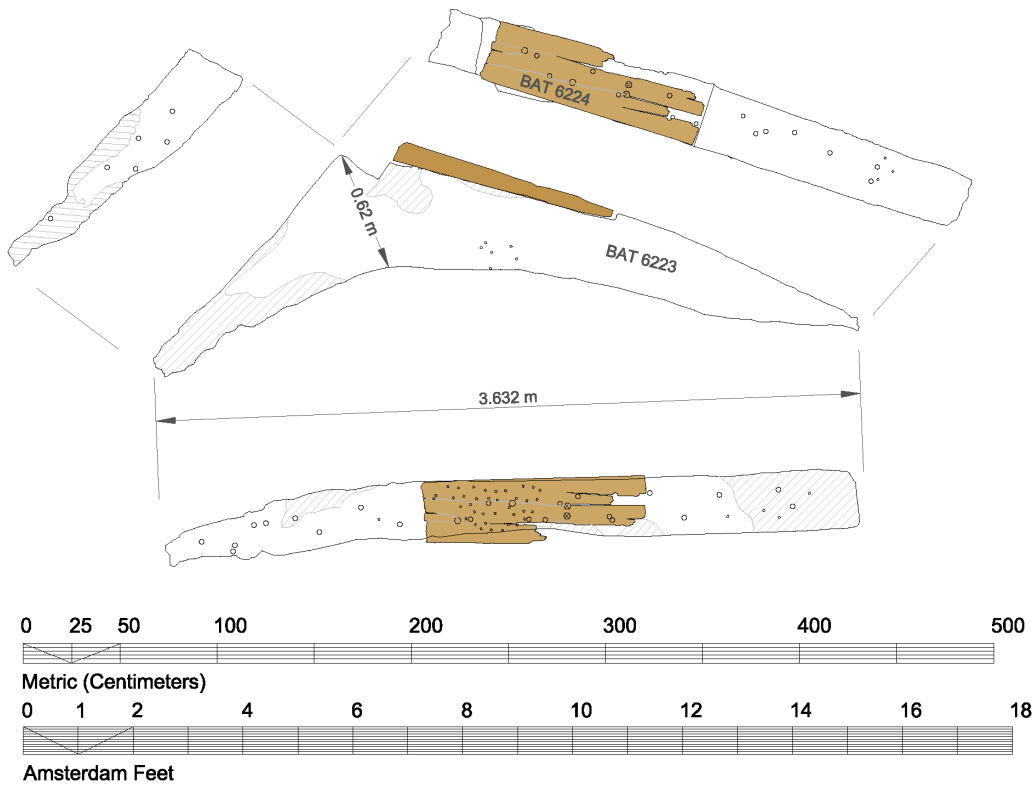
FIGURE 4-74.
Transom knee #4 and
its wedge (*highlighted
in brown*). Illustration
by author.

The measurements for the length of the transom knees were aligned between the tips of their ends (fig. 4-74). Furthermore, their thickness is measured from their exterior corner, where the two arms intersect, to their inner corner. They vary in preserved length from 2.65 to 3.60 m, from 35 to 36 cm in width, and from 31 to 62 cm in thickness.

The transom knees were notched at the exterior intersection of their arms to fit over the fashion piece and upper fashion piece. Additionally, the shipwrights adjusted the shape of the uppermost transom knees, as the exterior faces of both knees did not follow the curvature of the ship's hull, and, therefore, large wedges were inserted between the knee ends and ceiling planking to ensure a tight fit (see figs. 4-74 and 4-75).

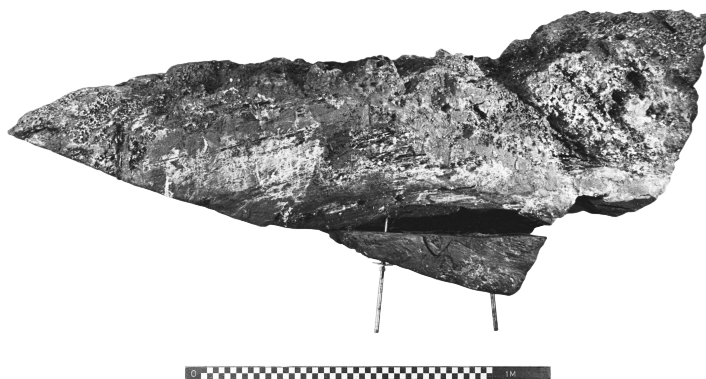
FIGURE 4-75.
View of top surface of
uppermost preserved
transom knee and its wedge,
BAT 6223 B. Not to scale.
Photograph by Brian Richards,
Western Australian Museum
(MA3294-01).

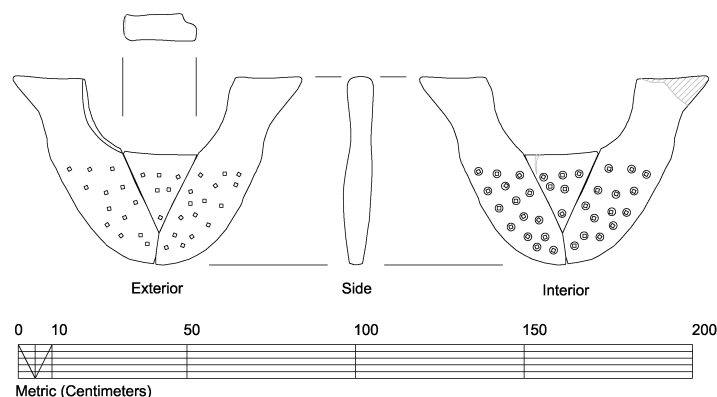
FIGURE 4-76.

Kevel, or belaying cleat, at aftermost end of lower deck, BAT 6220. Illustration by author.

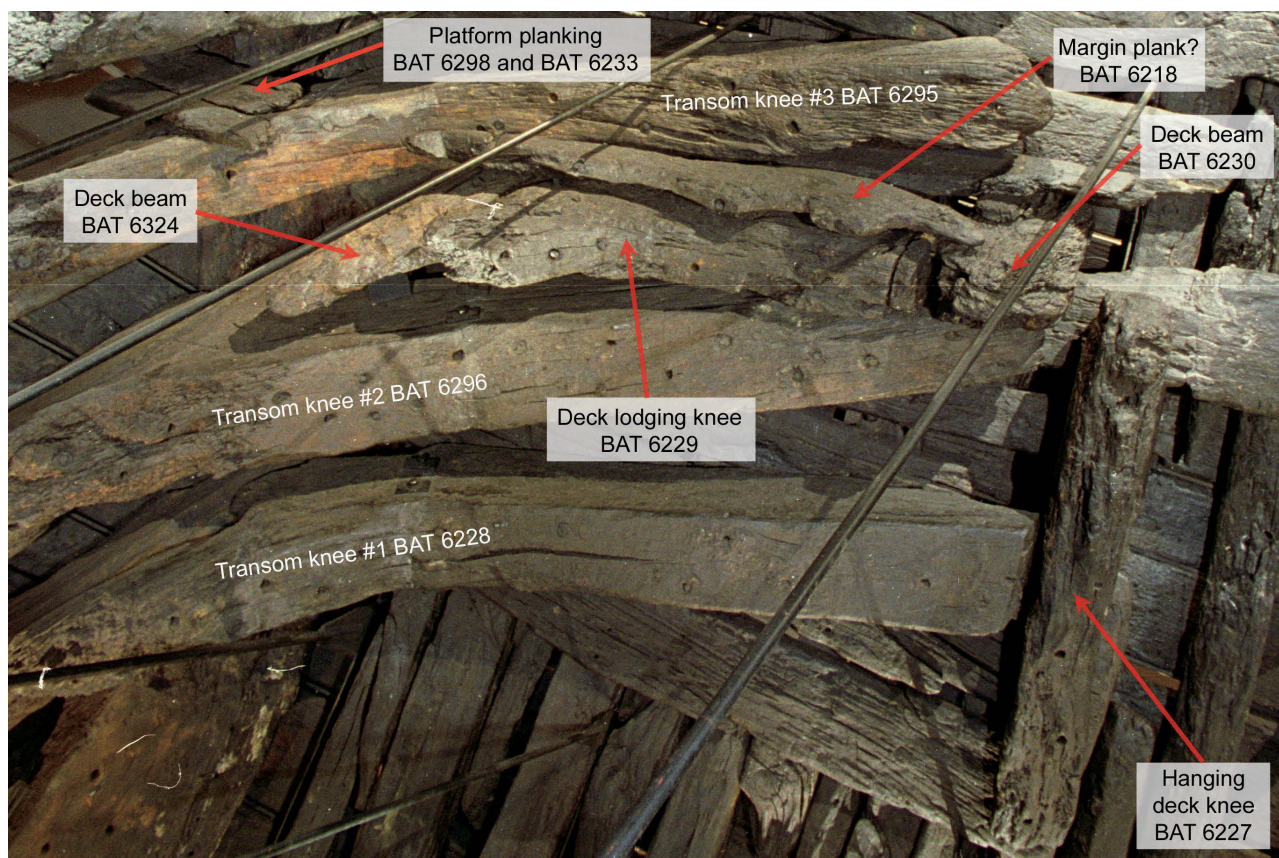
FIGURE 4-77. Deck timbers as displayed in the Western Australian Museum—Shipwreck Galleries. Photograph by Patrick Baker, Western Australian Museum (MA5049-30).

fragment of a hanging knee, a lodging knee, waterway, possibly a margin plank, and two fragmentary deck beams (fig. 4-77).

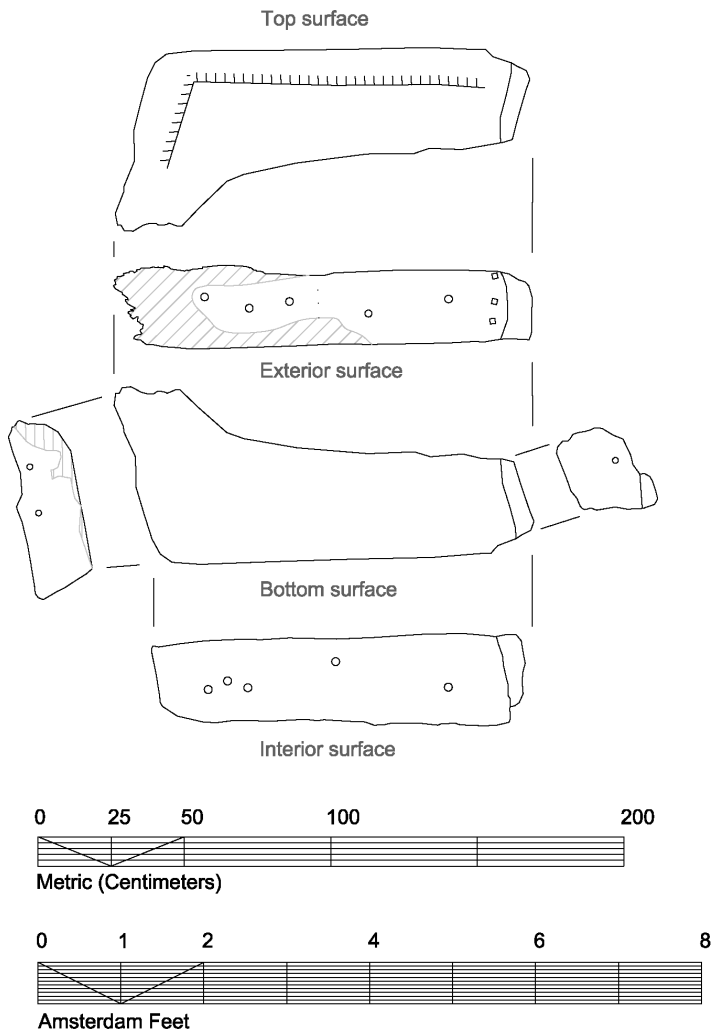
FIGURE 4-78.

Deck lodging knee, BAT 6229.

aftermost preserved remnant of deck beam BAT 6324. Between the two deck beams, one deck lodging knee, BAT 6229, has been preserved. The knee measures 1.49 m in length, 49 cm sided, and 28 cm molded (fig. 4-78). The timber was beveled on the exterior and aftermost edges of its top surface, probably to receive the waterway along the ship's side and transom. The knee was bolted to the ship's side, and its ends were fastened longitudinally to the deck beams. The forward end of this lodging knee rests on the forward arm

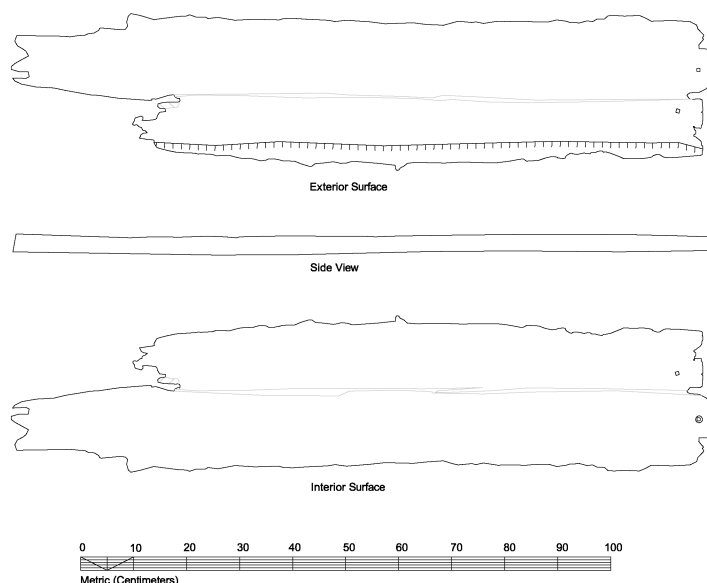
FIGURE 4-79.
Planking from area in between
transom knees #3 and #4.
Illustration by author.

The fragments were found near the deck timbers during the shipwreck's excavation, albeit between transom knees #3 and #4; therefore, they were not part of the deck (fig. 4-79). As their exact location and orientation were not recorded, their function cannot be determined; they might be part of the ceiling planking's cargo floor above transom knee #4. The preserved plank measures 1.32 m in length, 29 cm in width, and 3.6 cm in thickness.
